Attachment 4
Photograph Log

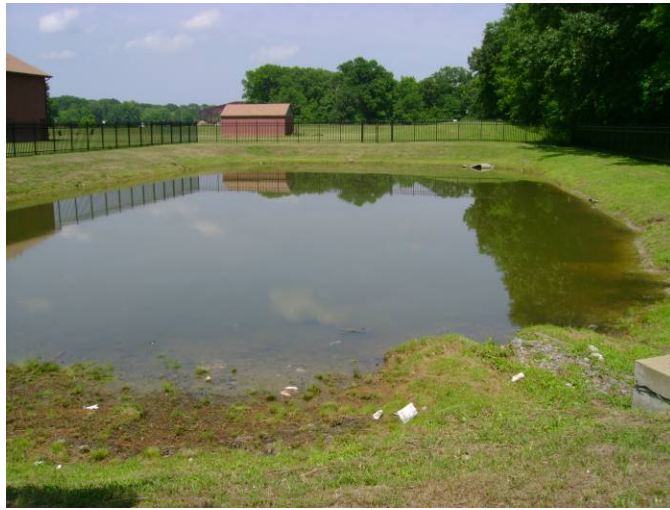
Photograph 1. Macedonia Baptist Church – Overview of stormwater management pond (facing east-northeast) with trash evident.

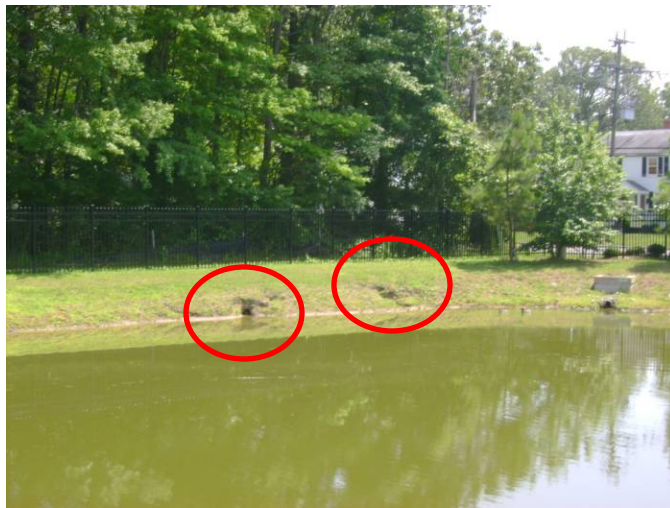
Photograph 2. Macedonia Baptist Church – Overview of stormwater management pond (facing south) with evidence of animal burrows on the embankment on the south bank of the pond.

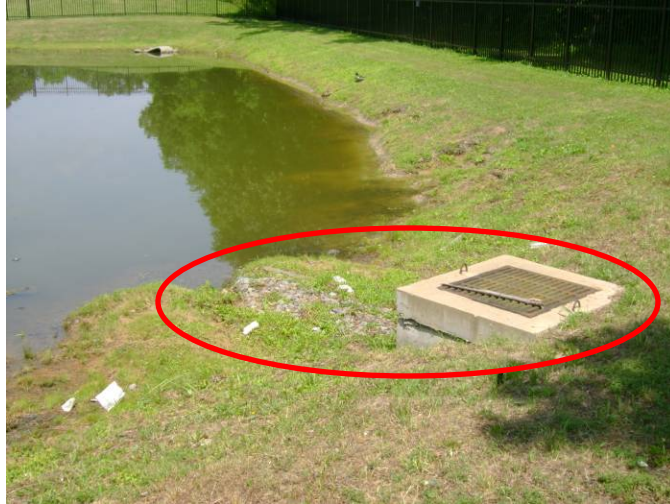
Photograph 3. Macedonia Baptist Church – Overview of stormwater management pond (facing south). Outlet structure was damaged and was need in repair or replacement.

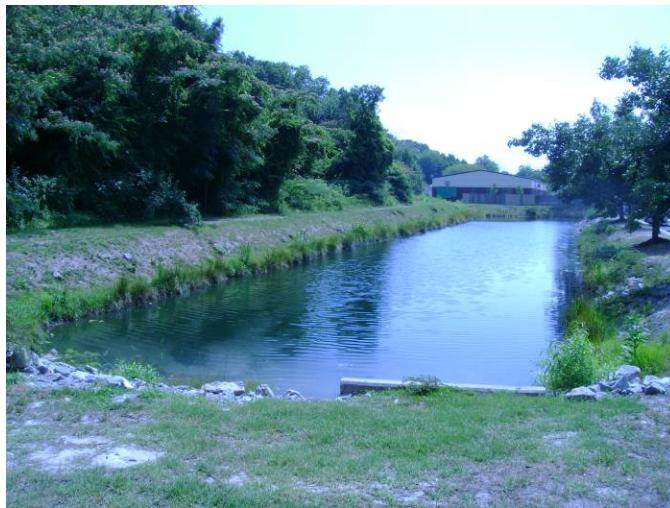
Photograph 4. San Francisco Condominium Association A – Overview of stormwater management pond (facing west southwest).

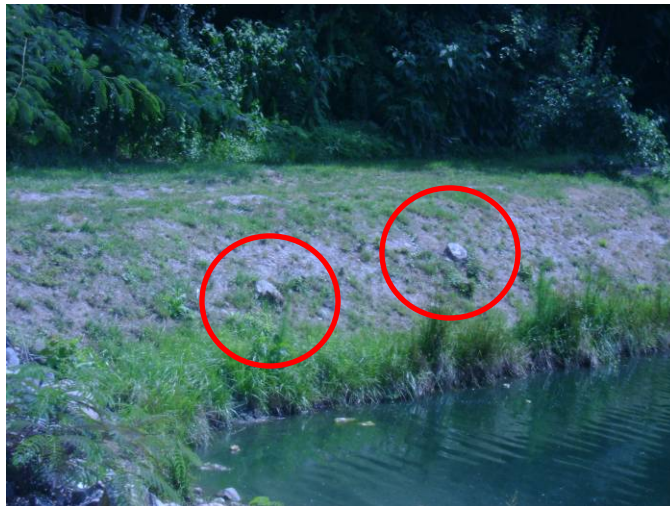
Photograph 6. San Francisco Condominium Association A – Recently repaired side slope on south side of pond. Note lack of healthy vegetation on slope resulting in bare spots and two tree stumps (circled in red).

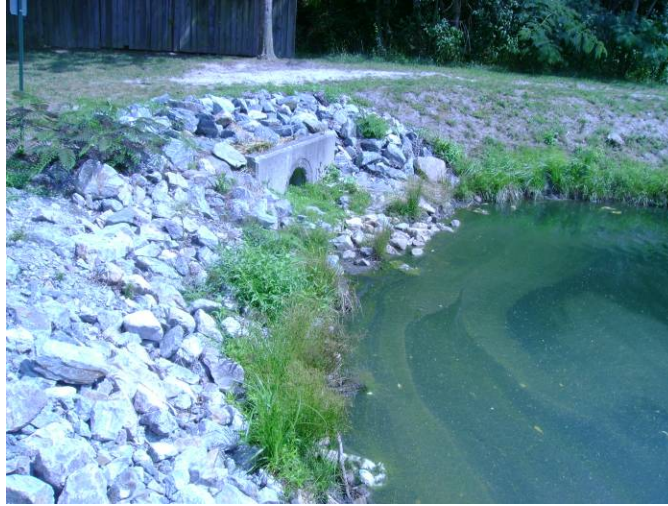
Photograph 7. Francisco Condominium Association A – Stormwater management pond inlet on eastern portion of pond. Note the algae on water.

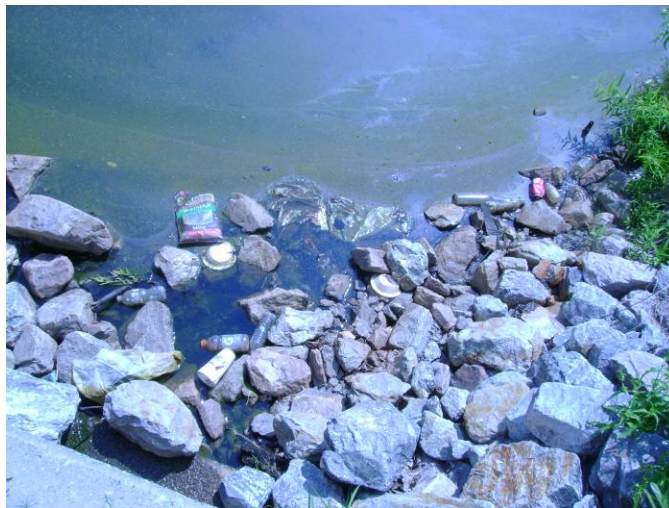
Photograph 8. Francisco Condominium Association A – Note algae sheen and trash near pond inlet in previous photo.

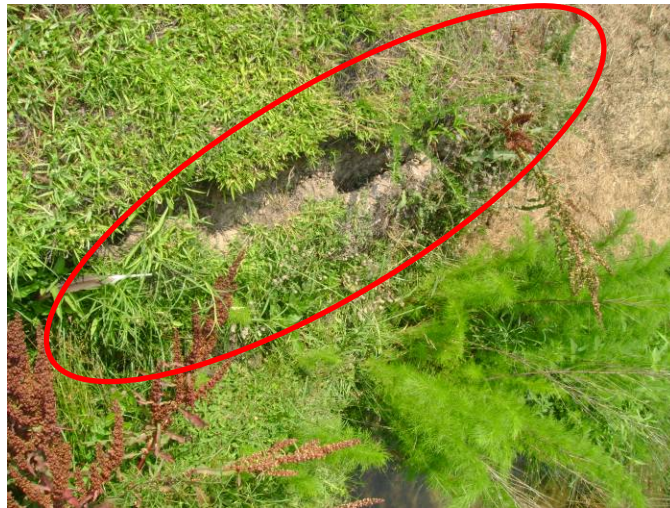
Photograph 12. Police Headquarters – Another example of erosion on the bank of the stormwater management pond.

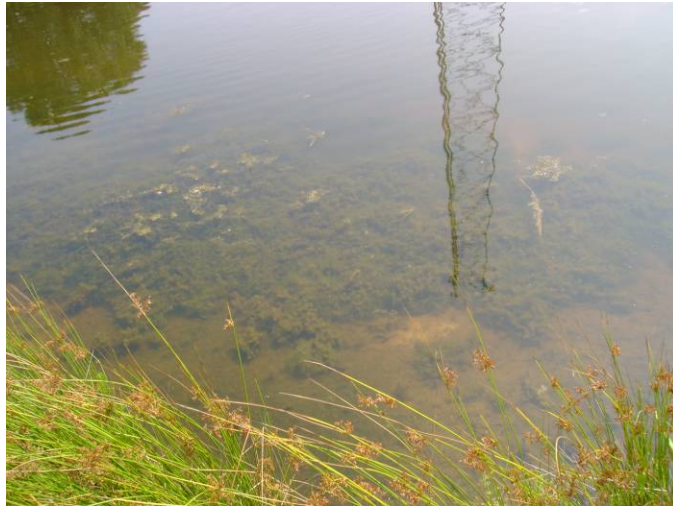
Photograph 15. Police Headquarters – Algae growth in stormwater management pond.

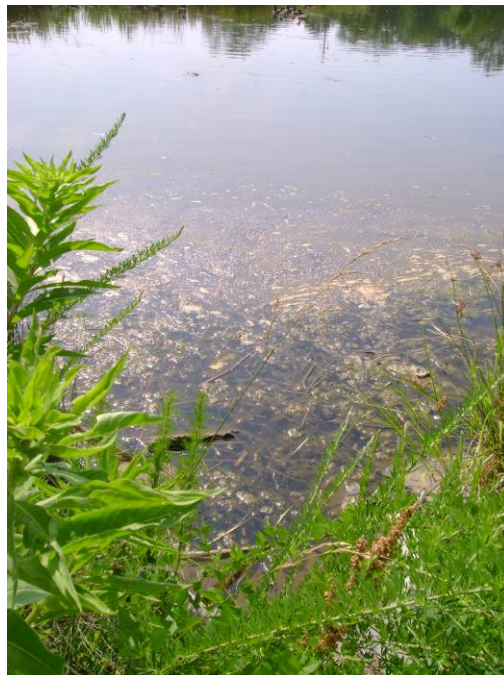
Photograph 16. Police Headquarters – Another view of algae growth in stormwater management pond.

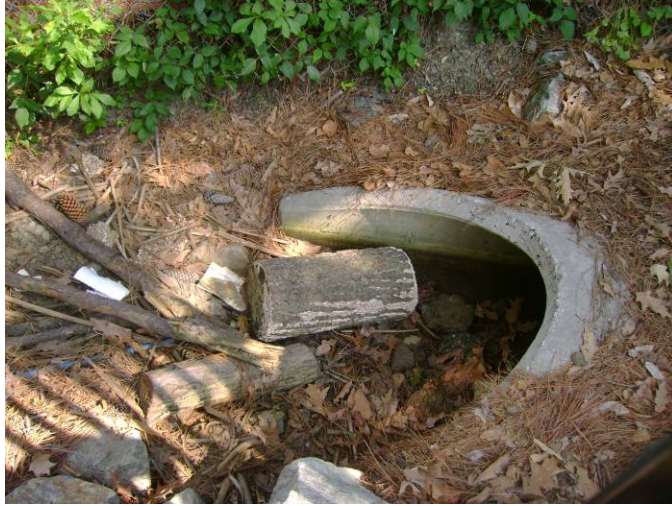
Photograph 17. Police Headquarters – Stormwater culvert apron located along the northeast portion of the site. Note that City personnel were not familiar with the directional flow of the culvert and whether the culvert was draining into the pond or out of the pond.

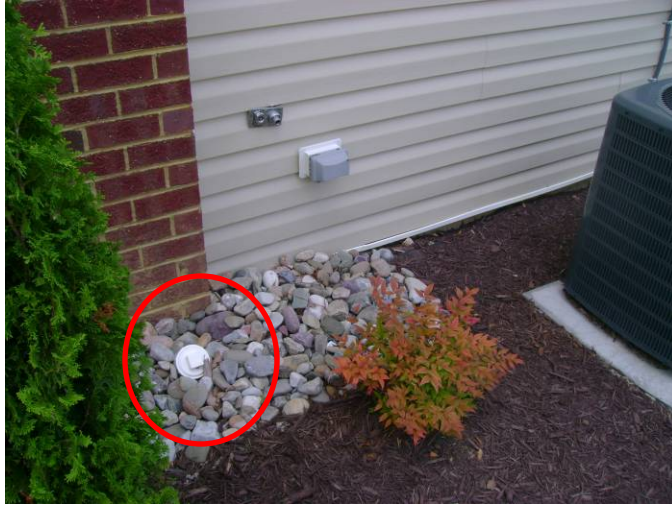
Photograph 21. Unknown PVC pipe located on side of building adjacent to the stormwater management pond near the community car wash area that appears to terminate in the stormwater management pond. Note that it is potentially a clean out for a roof drain or air conditioning condensate.

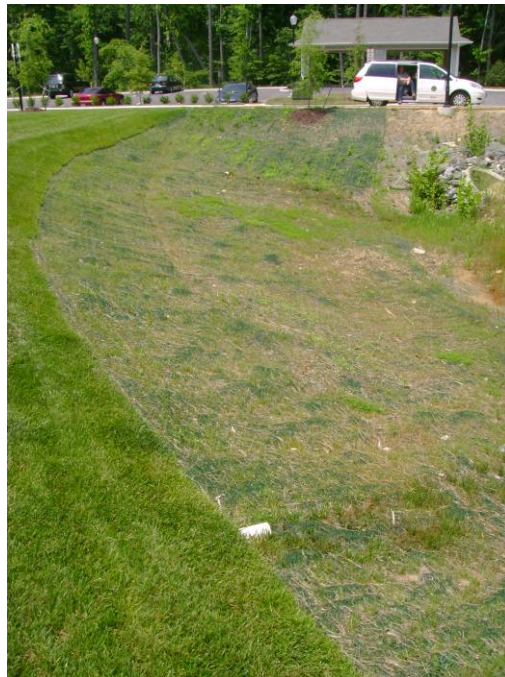
Photograph 22. Windy Knolls – Apparent terminus of the unknown PVC pipe at the edge of the stormwater management pond noted in previous photograph. Note stressed vegetation along side slope near van in background of photopgraph.

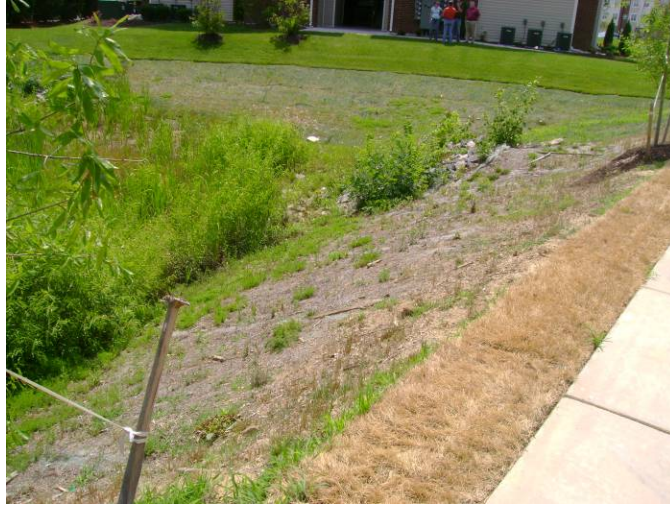
Photograph 23. Windy Knolls – Dying vegetation along bank and sideslope of the stormwater management pond near the community car wash area.

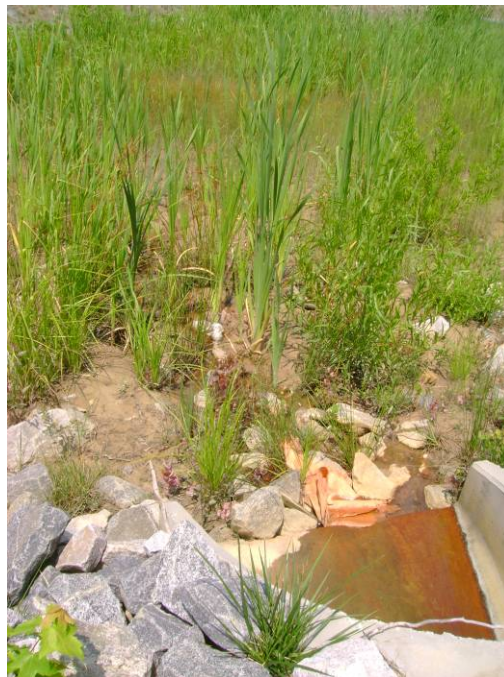
Photograph 24. Windy Knolls – Sediment noted in and around inlet to stormwater management pond near the community car wash area.

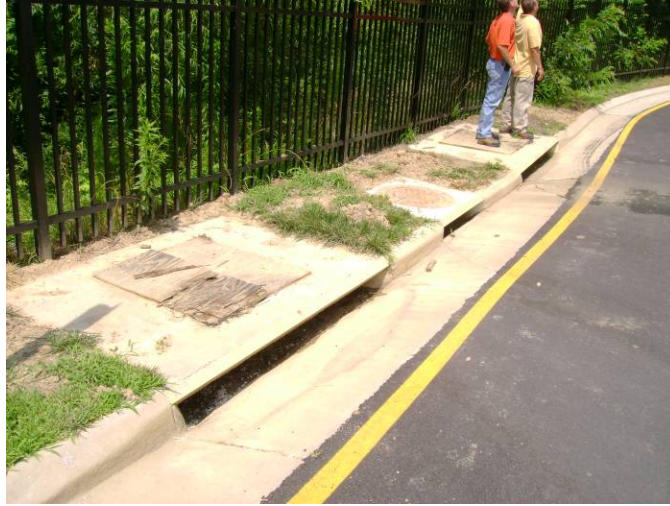
Photograph 25. Windy Knolls – Filterterra® unit installed near the boundary of the property adjacent to the community car wash area. Note the lack of controls to prevent sediment from construction activities from entering unit.

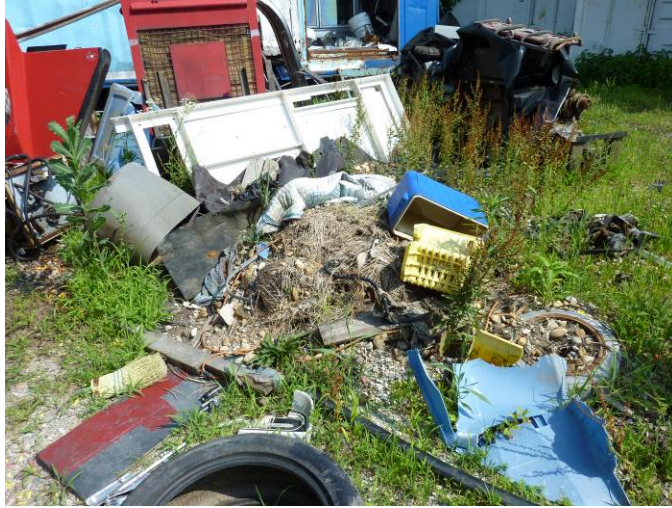
Photograph 29. Pete's Used Auto Parts - Trash and debris strewn outside

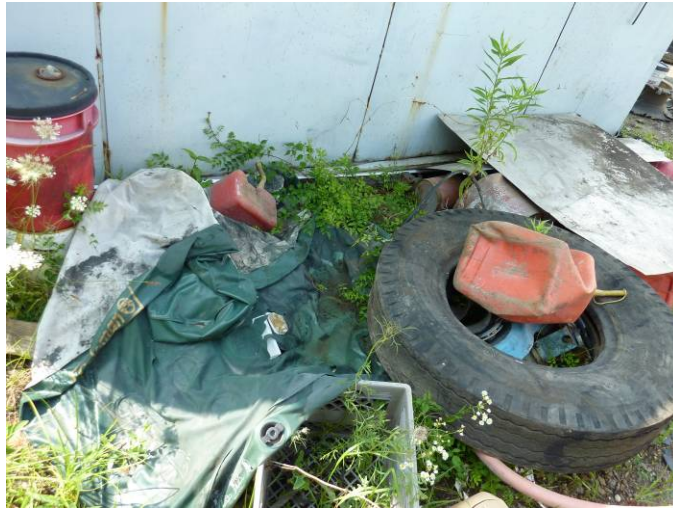
Photograph 30. Pete's Used Auto Parts – Gas tanks, tires and other debris left outside

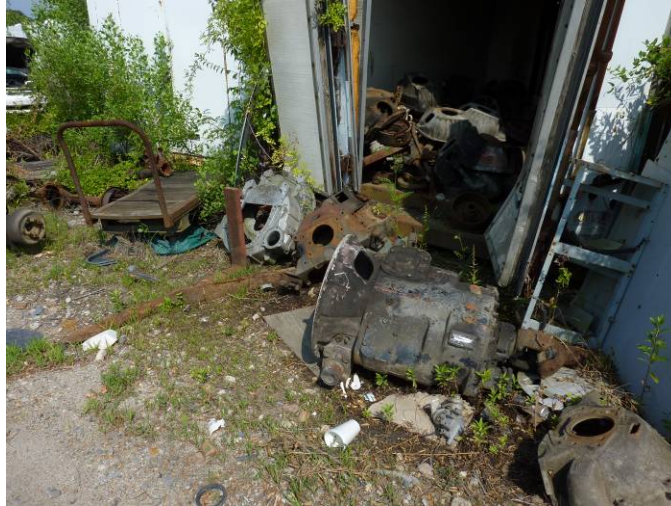
Photograph 31. Pete's Used Auto Parts – Rusty metal car parts left outside

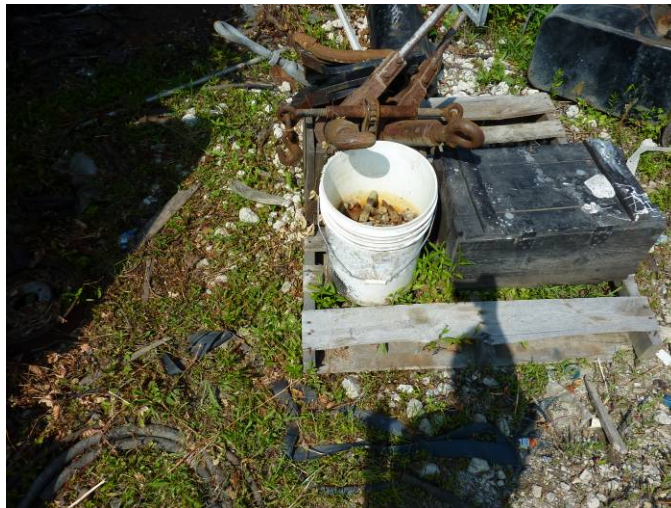
Photograph 32. Pete's Used Auto Parts – Rusty metal left outside

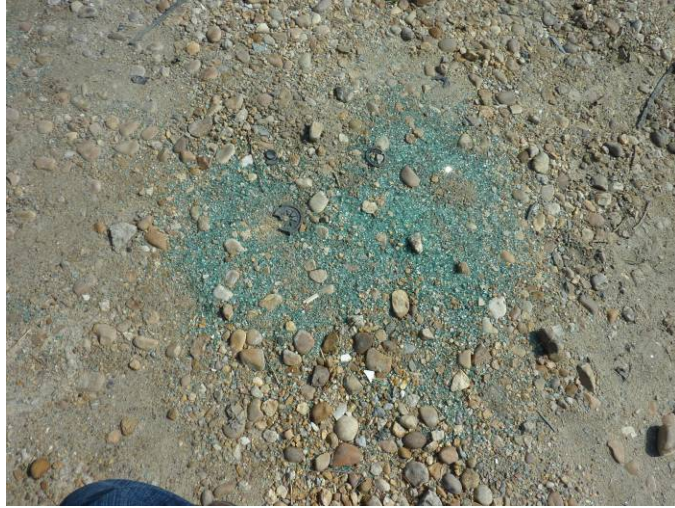
Photograph 33. Pete's Used Auto Parts – Broken glass located outside

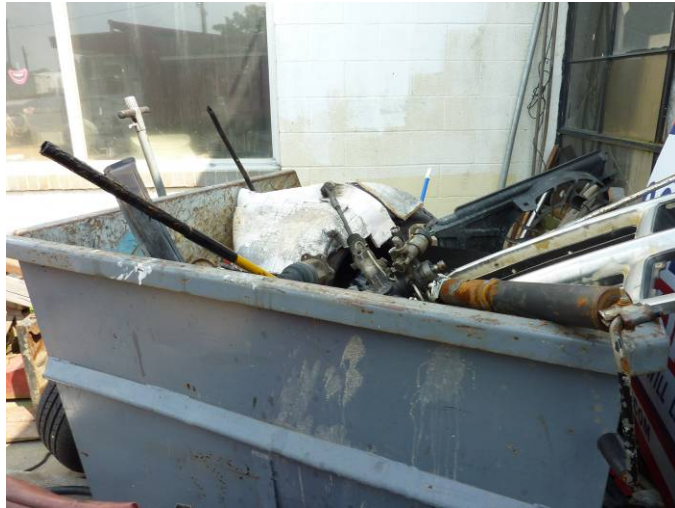
Photograph 34. Pete's Used Auto Parts – Open dumpster containing metal located outside

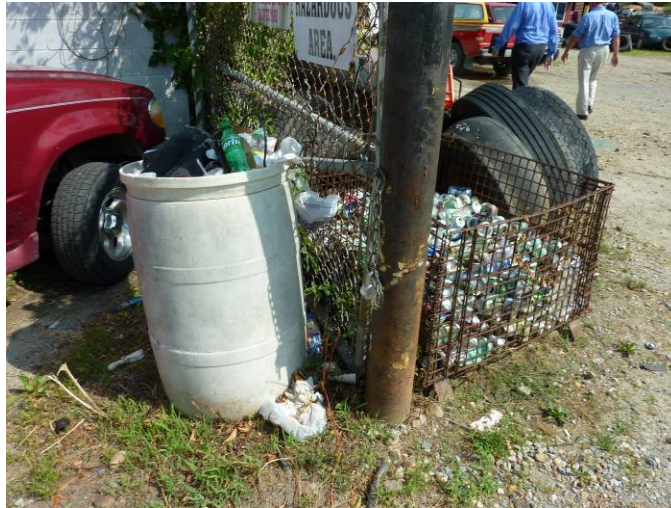
Photograph 35. Pete's Used Auto Parts – Overflowing, uncovered trash can located outside

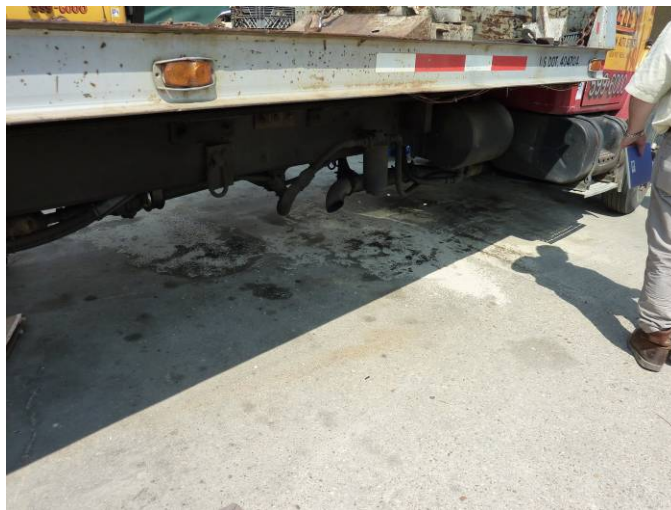
Photograph 36. Pete's Used Auto Parts – Oil drying material that had not been cleaned up

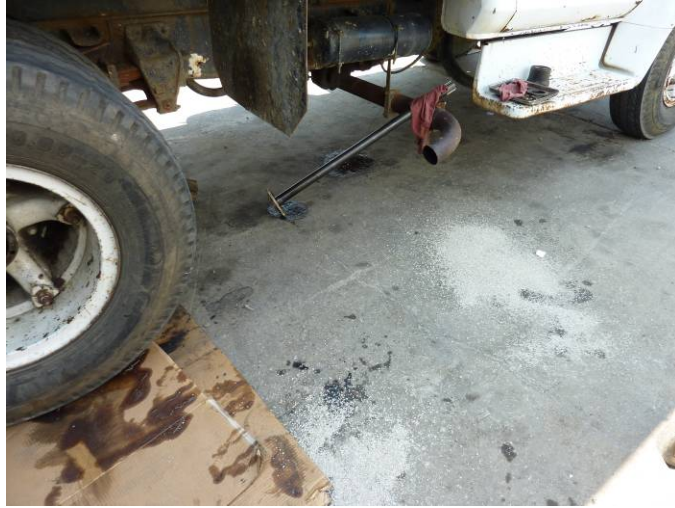
Photograph 37. Pete's Used Auto Parts – Oil drying material that had not been cleaned up

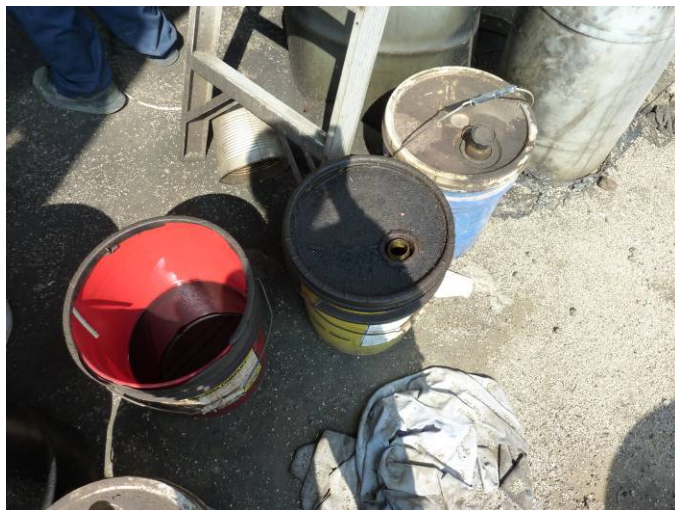
Photograph 38. Pete's Used Auto Parts – Oil drying material that had not been cleaned up and buckets containing product located outside

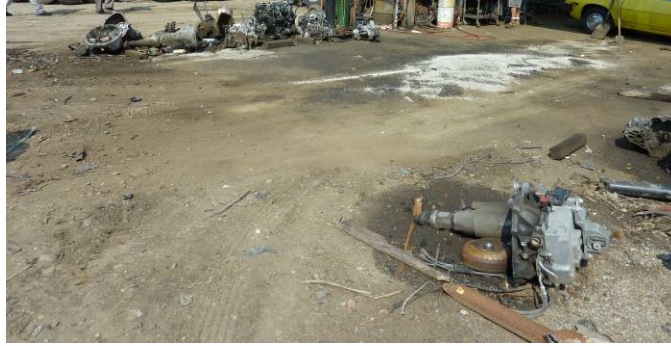
Photograph 39. Pete's Used Auto Parts – Oil drying material that had not been cleaned up and oil staining around engines and car parts

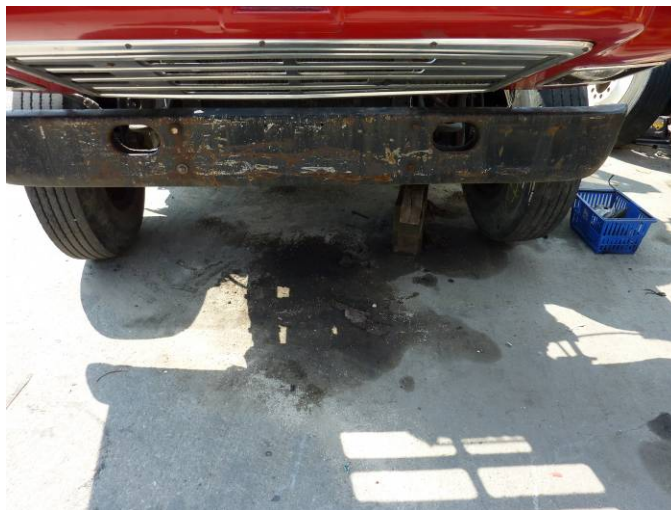
Photograph 40. Pete's Used Auto Parts – Oil staining

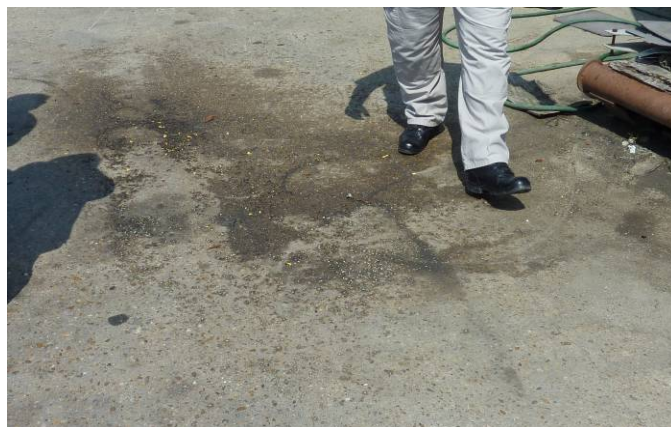
Photograph 41. Pete's Used Auto Parts – Oil staining

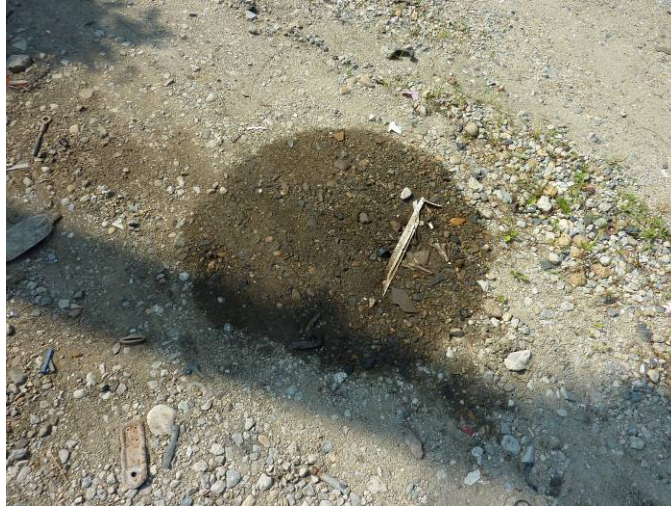
Photograph 42. Pete's Used Auto Parts – Oil staining

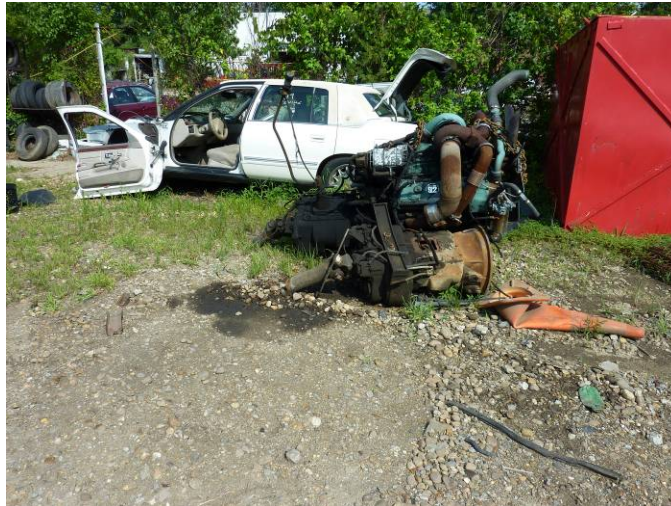
Photograph 43. Pete's Used Auto Parts – Oil staining around car engine

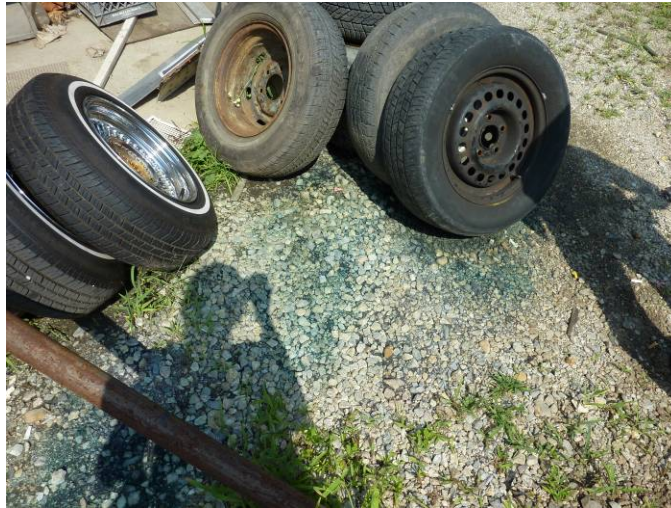
Photograph 44. Pete's Used Auto Parts – Blue-green staining located outside

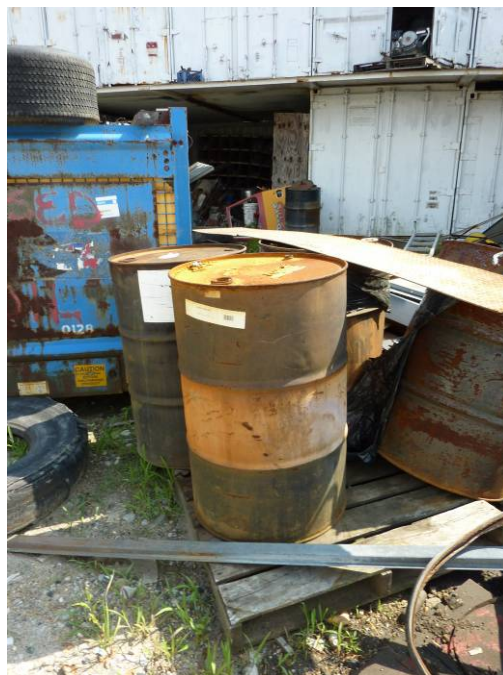
Photograph 45. Pete's Used Auto Parts – Drums located outside

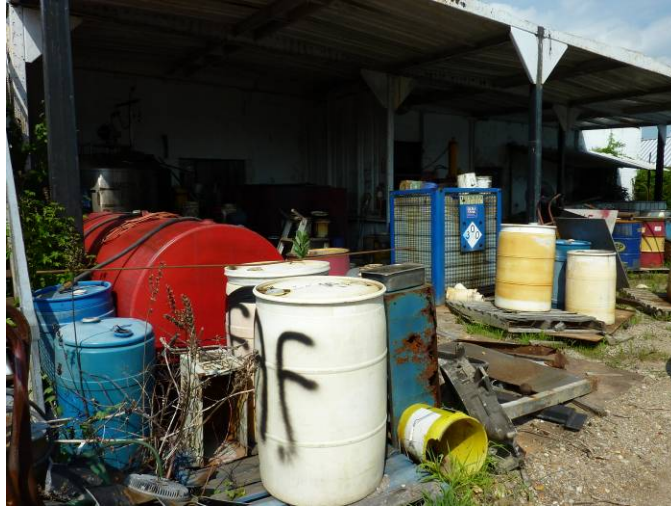
Photograph 46. Pete's Used Auto Parts – Drums, buckets, and tanks located outside

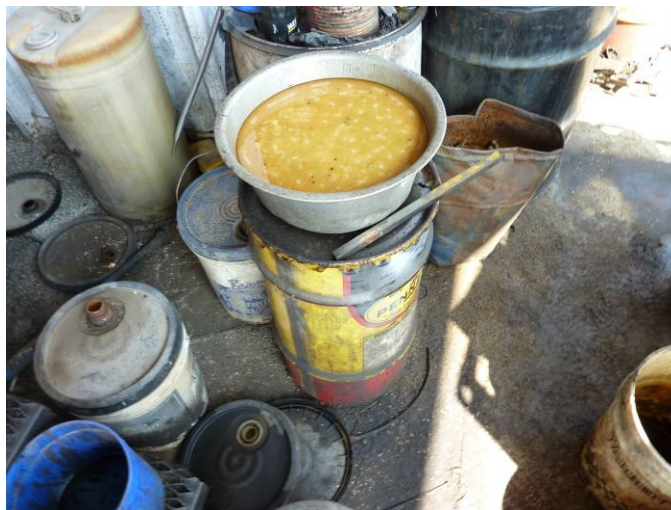
Photograph 47. Pete's Used Auto Parts – Tub and buckets containing oily products located outside under roofed area

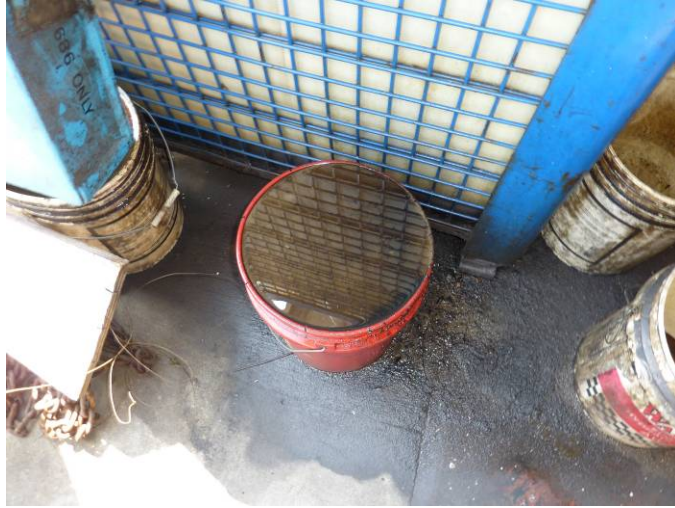
Photograph 48. Pete's Used Auto Parts – Bucket, located outside under roofed area, filled to the top with oil and water. The area surrounding the bucket was wet.

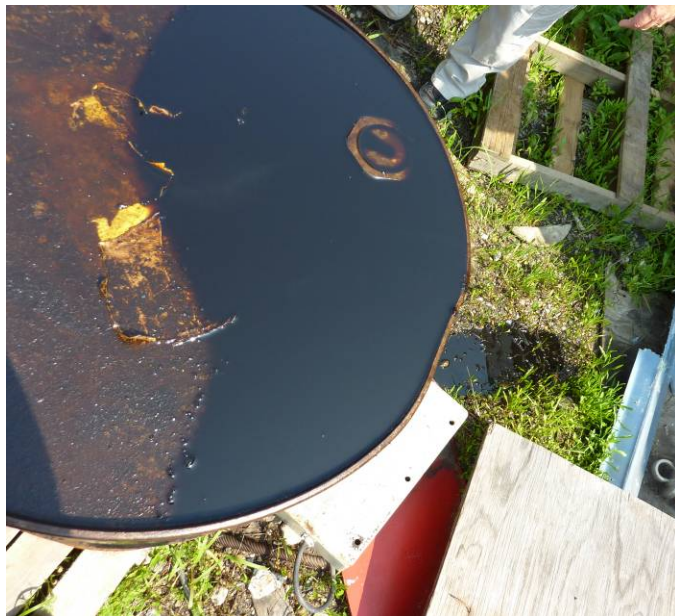
Photograph 49. Pete's Used Auto Parts – Oil drum leaking oil onto grassy area

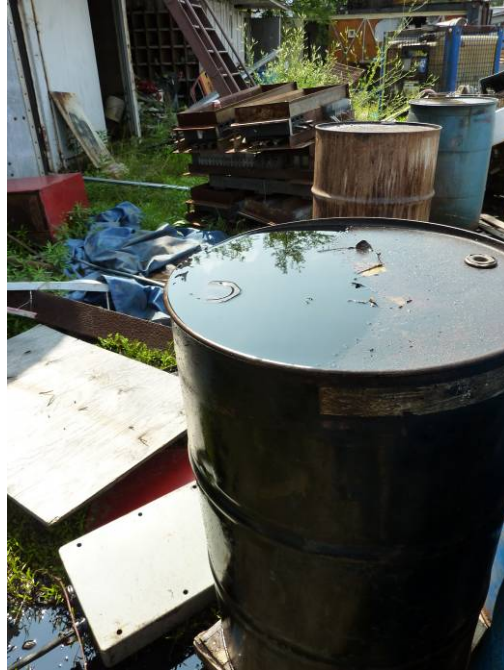
Photograph 50. Pete's Used Auto Parts – Oily residue on the side of the leaking drum

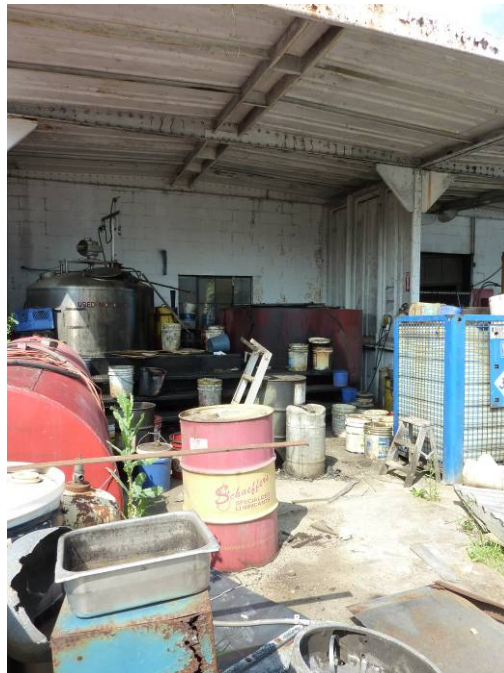
Photograph 51. Pete's Used Auto Parts – View of the two large oil tanks located under the roofed area outside

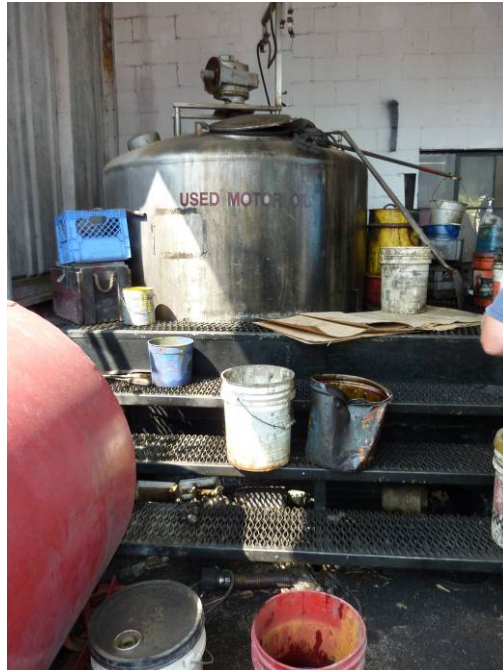
Photograph 52. Pete's Used Auto Parts – Oil staining on and around silver oil tank

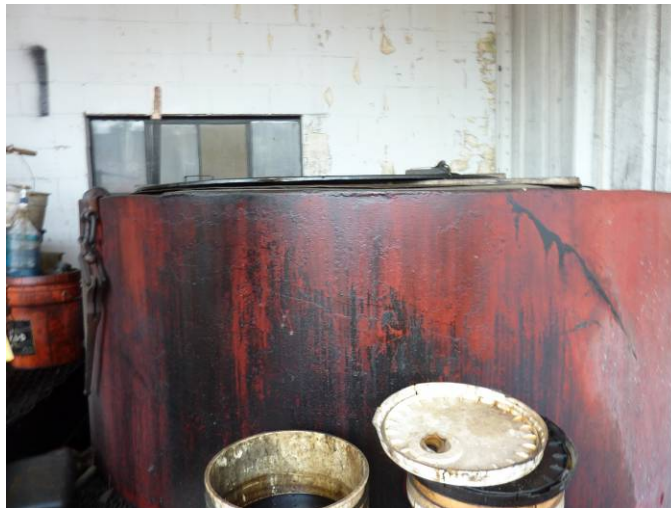
Photograph 53. Pete's Used Auto Parts – Oil staining on red oil tank

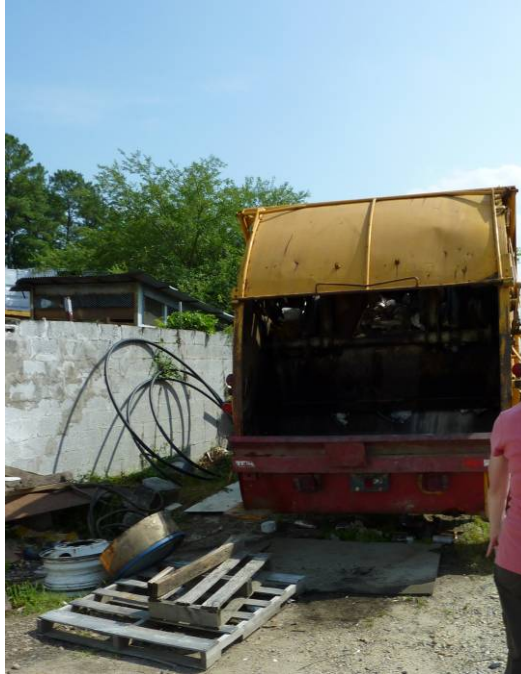
Photograph 54. Pete's Used Auto Parts – Open dump truck containing trash located outside

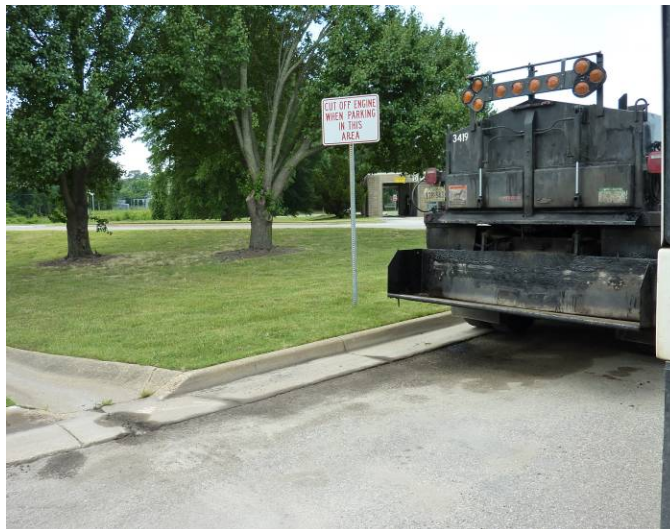
Photograph 55. City Vehicle Maintenance Garage – Truck leaking oil near concrete drainage ditch

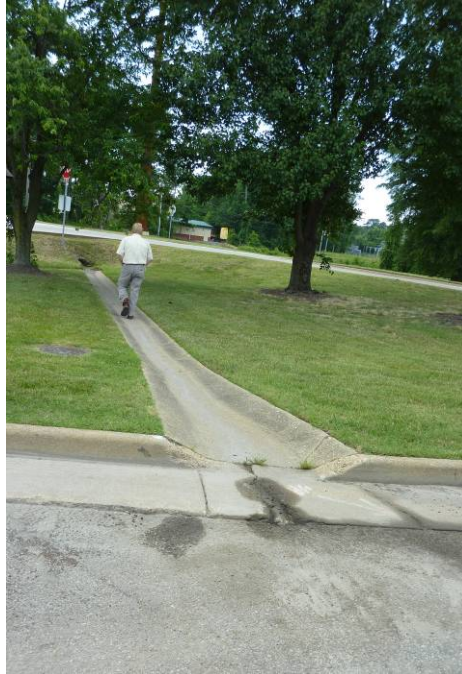
Photograph 56. City Vehicle Maintenance Garage – View of oil stain at the entrance to the drainage ditch

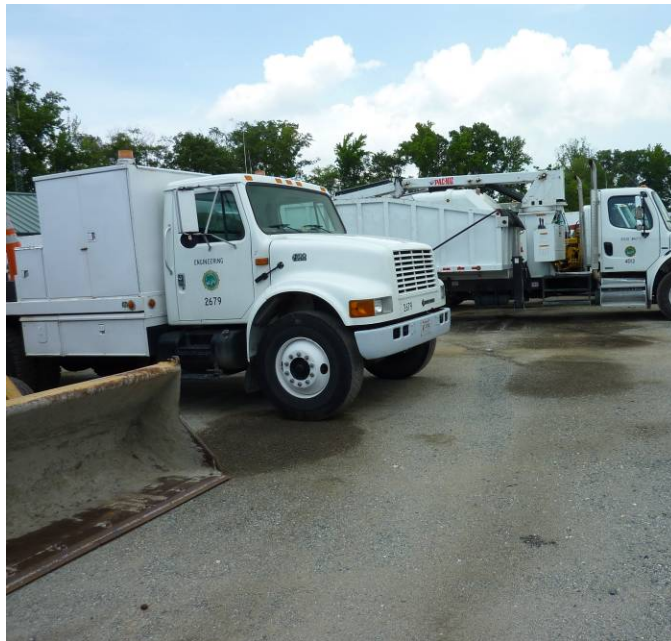
Photograph 57. City Vehicle Maintenance Garage – Oil stains in truck parking area

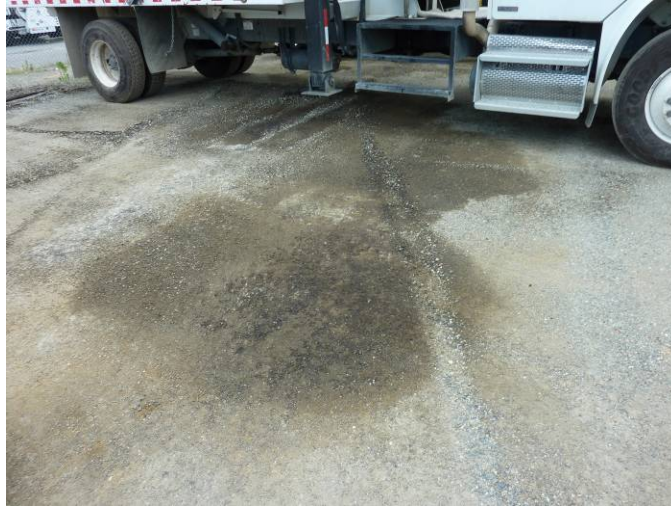
Photograph 58. City Vehicle Maintenance Garage – Oil staining

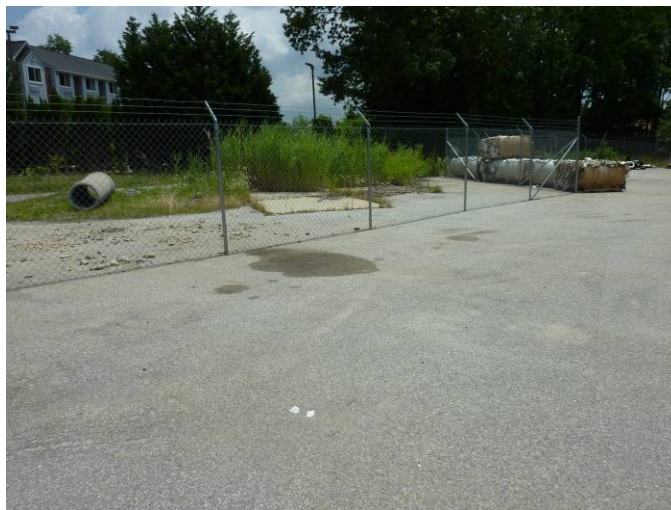
Photograph 59. City Vehicle Maintenance Garage – Oil staining

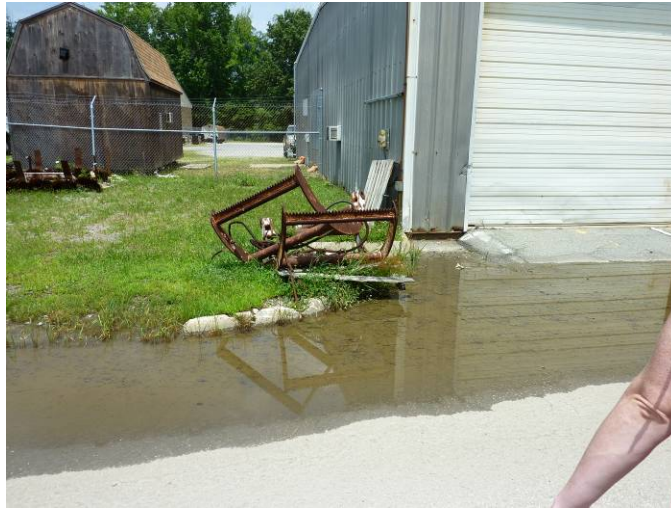
Photograph 60. City Vehicle Maintenance Garage – Rusty metal located outside

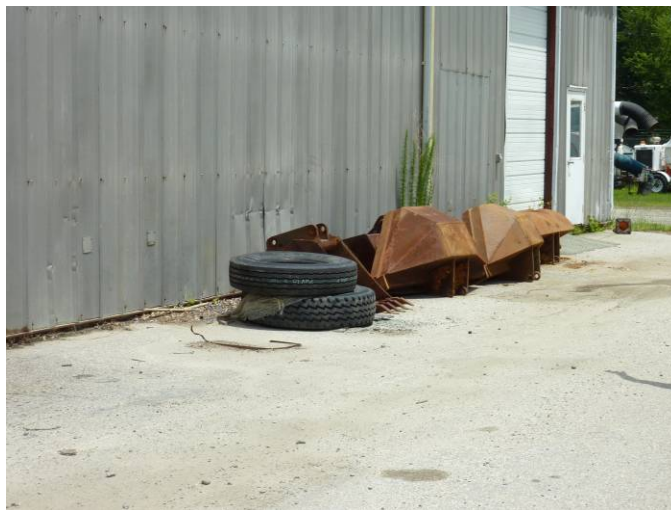
Photograph 61. City Vehicle Maintenance Garage – Rusty metal equipment located outside

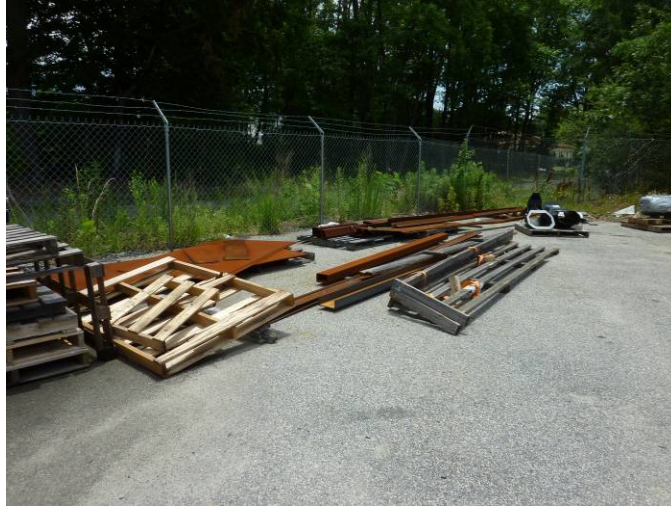
Photograph 62. City Vehicle Maintenance Garage – Rusty metal located outside

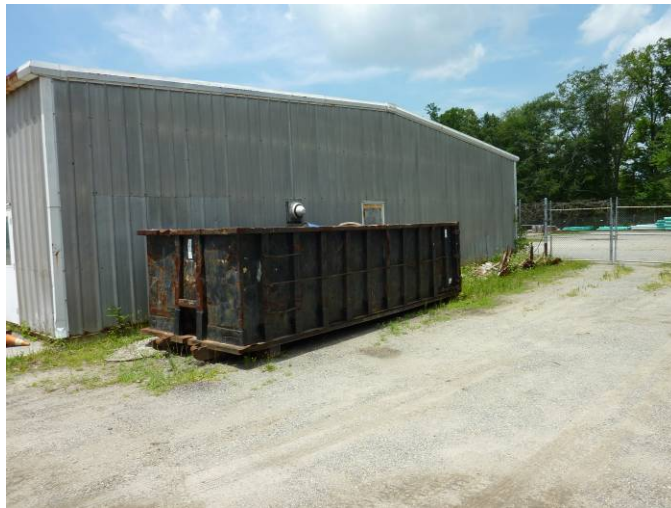
Photograph 63. City Vehicle Maintenance Garage – Open partially-filled dumpster

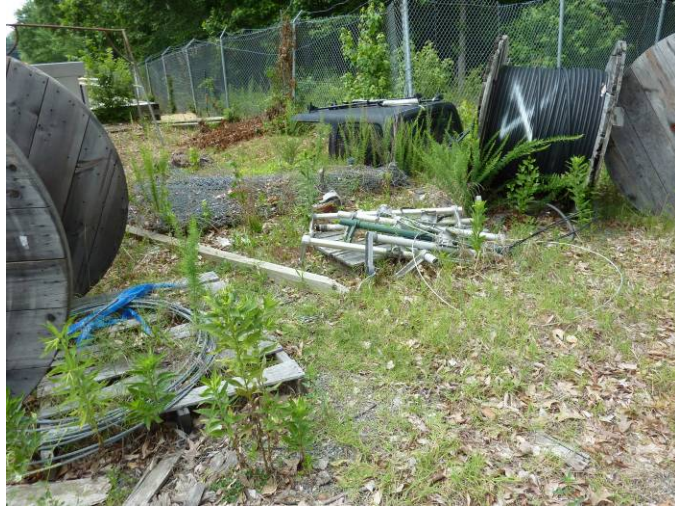
Photograph 64. City Traffic Operations Facility – Metal located outside

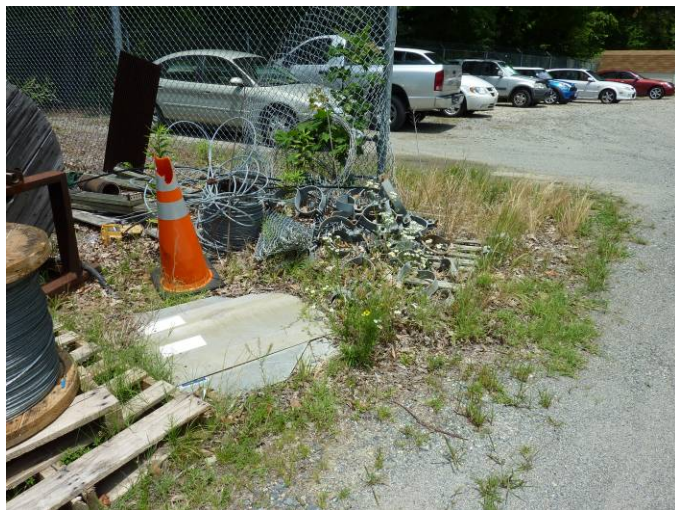
Photograph 65. City Traffic Operations Facility – Metal located outside

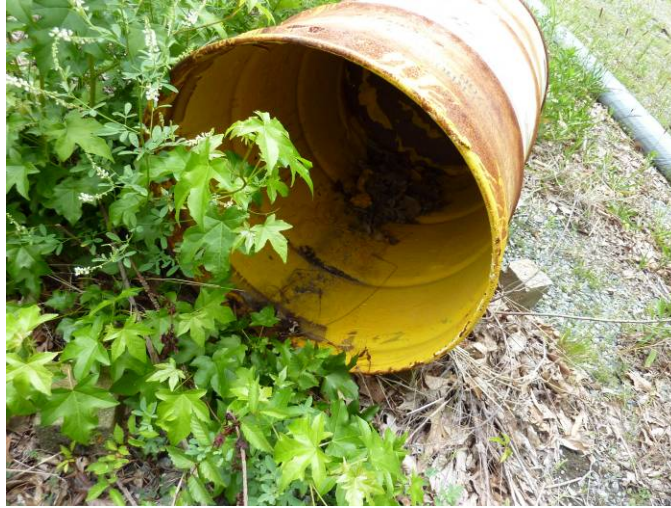
Photograph 66. City Traffic Operations Facility – Open paint drum coated on the inside with dried paint laying on its side

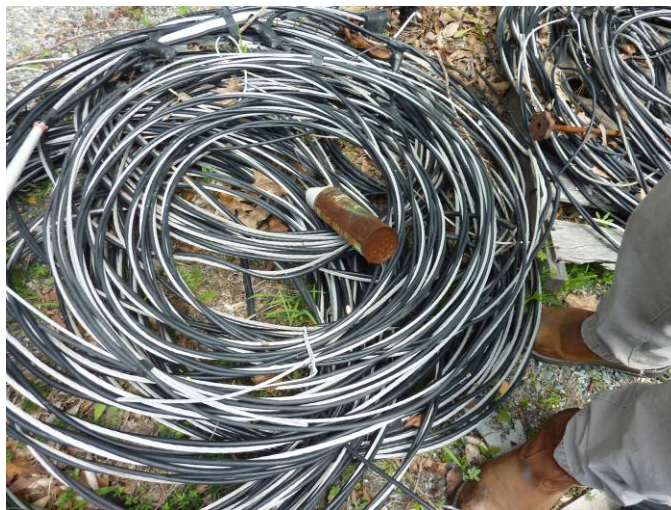
Photograph 67. City Traffic Operations Facility – Rusty spray paint can located outside

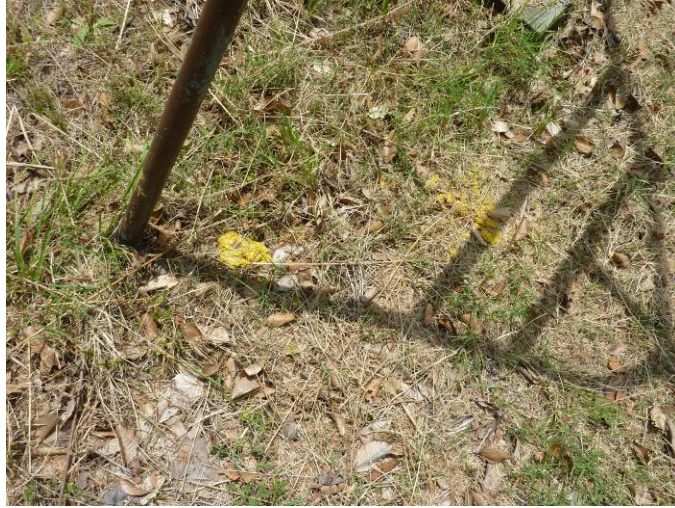
Photograph 68. City Traffic Operations Facility – Paint spills on grass

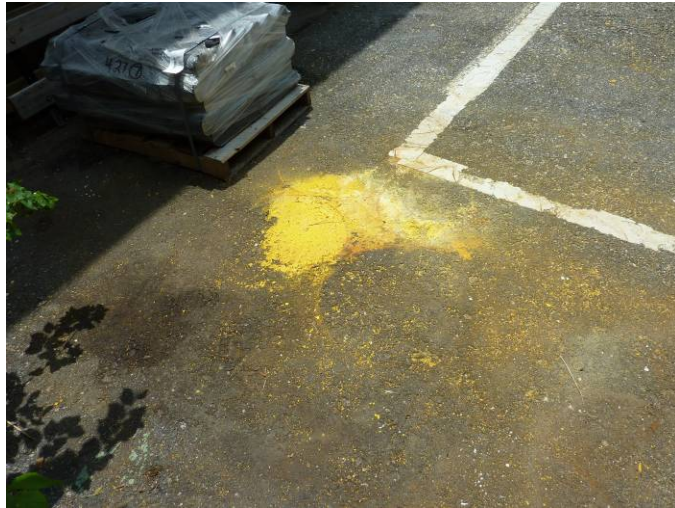
Photograph 69. City Traffic Operations Facility – Paint spill stains on paved area

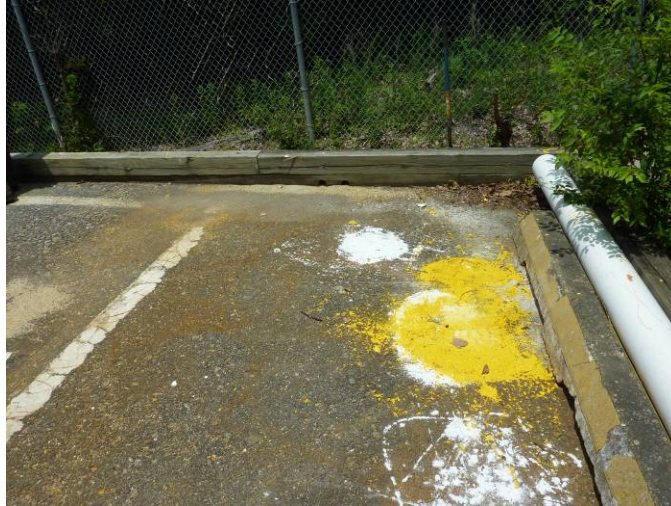
Photograph 70. City Traffic Operations Facility – Paint spill stains on paved area

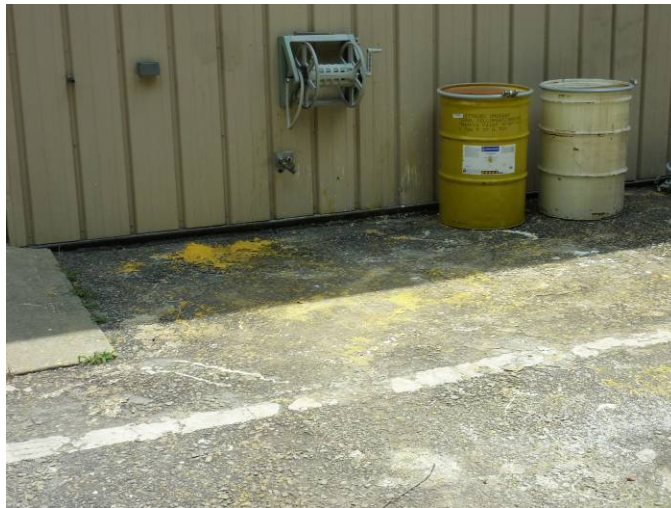
Photograph 71. City Traffic Operations Facility – Paint spill stains on paved area and paint drums located outside

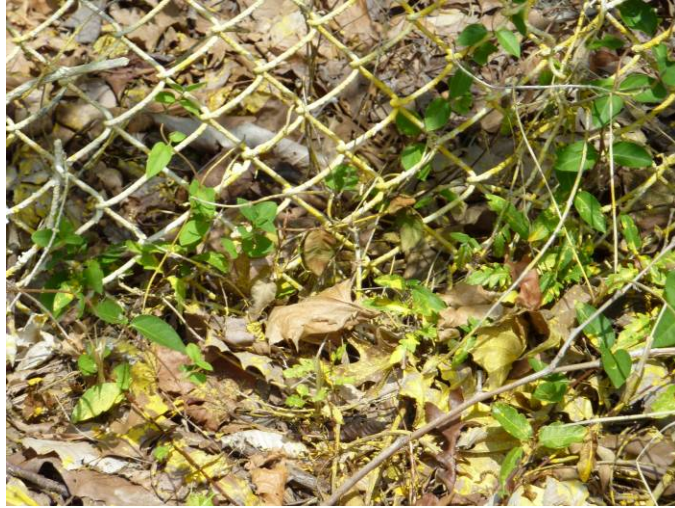
Photograph 72. City Traffic Operations Facility – Paint spray through fence onto vegetated area near surface water

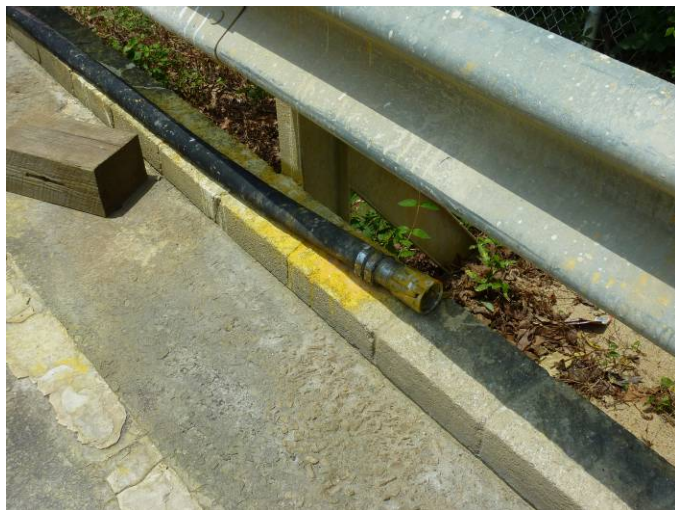
Photograph 73. City Traffic Operations Facility – Paint spray hose and spill on curb

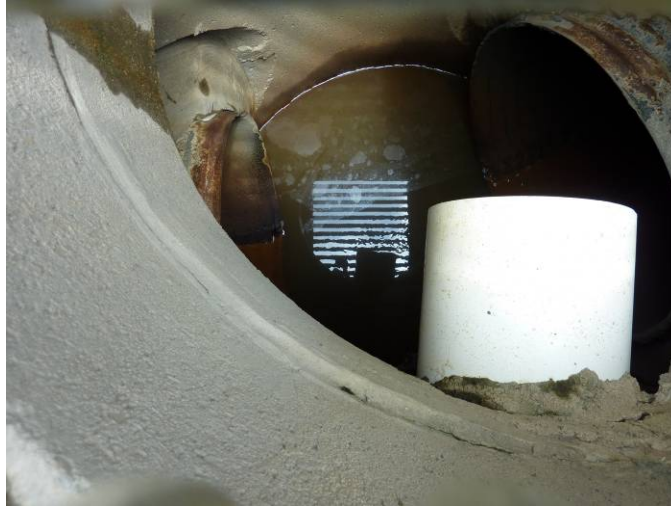
Photograph 76. Municipal Yard Storm Drain – Oily desposits and sheen on turbid brown water
